EXPERIMENTAL INVESTIGATION OF AIR-COOLED

TURBINE BLADES IN TURBOJET ENGINE

X - ENDURANCE EVALUATION OF SEVERAL

TUBE-FILLED ROTOR BLADES

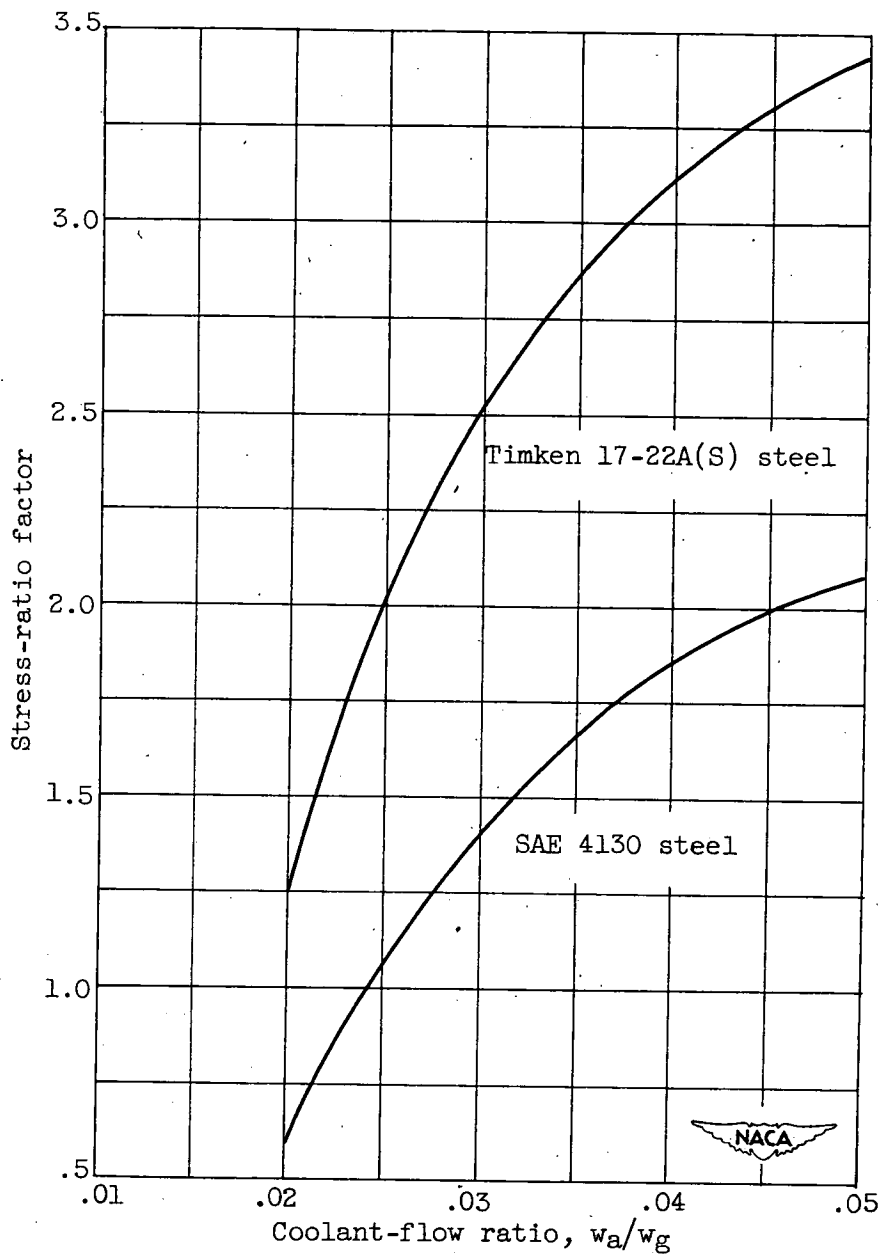
Figure 15. - Comparison of cooling-air requirements for blades made of SAE 4130 and Timken 17-22A(S) steels. Temperature and stress distributions for blade 12 with air bled from compressor at rated engine speed; effective gas temperature,  $1450^{\circ}\text{F}$ ; cooling-air temperature,  $450^{\circ}\text{F}$ .
